Module #6 Cold Mass Assembly Outside of the Clean Room

Dan Olis

Day 17 - June 12, 2006

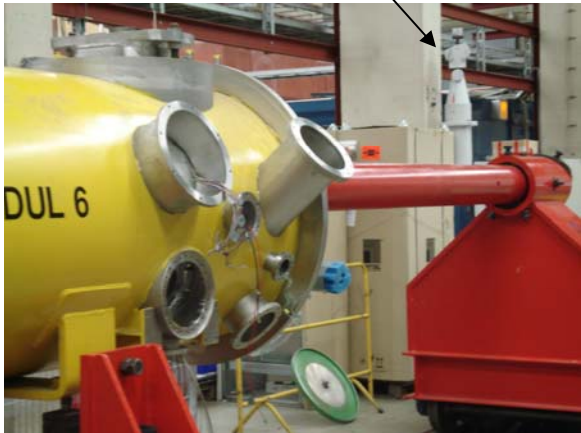
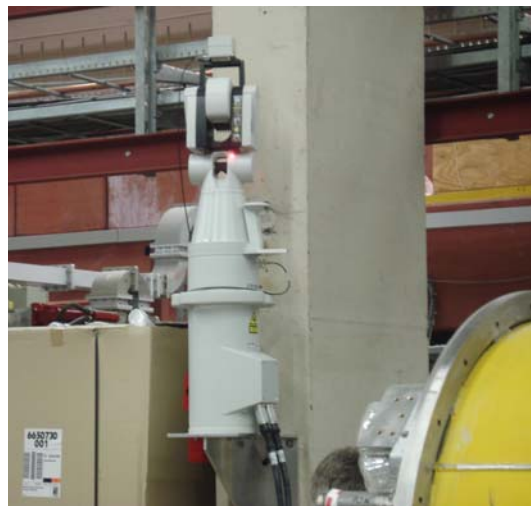
Laser tracker
mounted on column.

With cold mass and vacuum vessel assembled and course alignment complete, today's task was final alignment of cold mass to vacuum vessel. The alignment crew arrived at 9am and finished by 3pm. They set up both a laser tracker and a traditional optical (theodolite) measurement device. Surveyors are learning to use laser tracker so both instruments used.

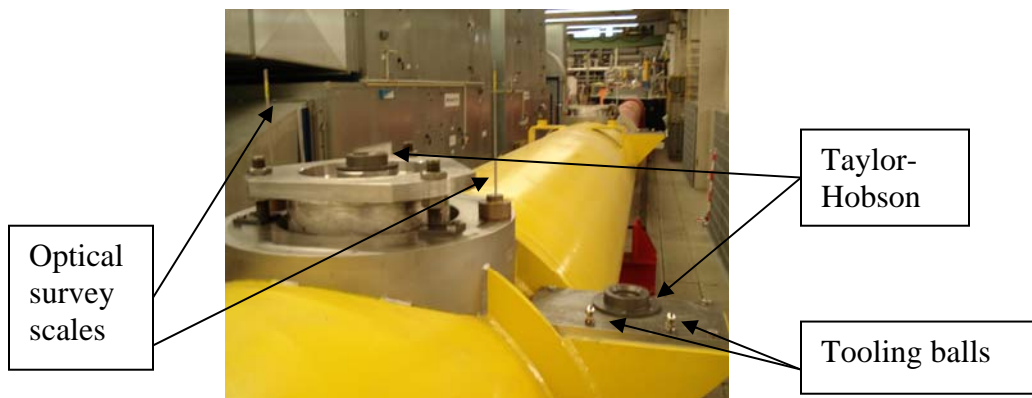
Optical measurement used brass survey mounts with 30cm scales installed. Some mounts are flat-bottomed and sat atop the vacuum vessel's cold mass mount flanges. The other optical survey mounts include a spherically-shaped feature for installation into Taylor-Hobson cup mounts installed on both the vessel and the cold mass support posts. One pair of tooling balls (~20mm diameter) was installed on the horizontal survey bracket at each of the cold mass support flanges.

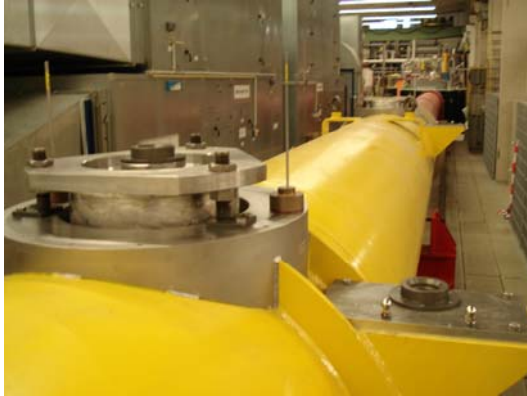
1. Survey elevation of cold mass mounting flanges on top of vessel with respect to level earth.

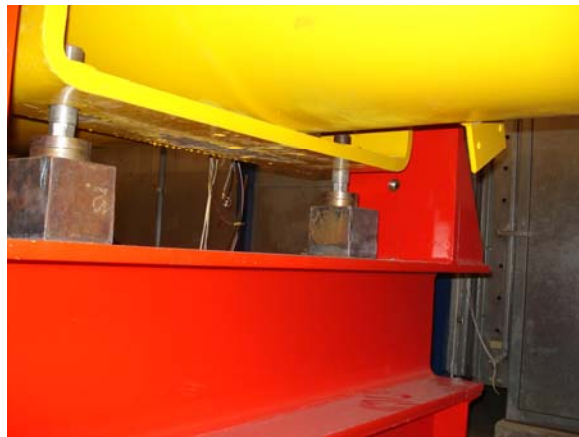
2. Level these surfaces (the cryomodule) by adjusting screw jack feet of vacuum vessel.

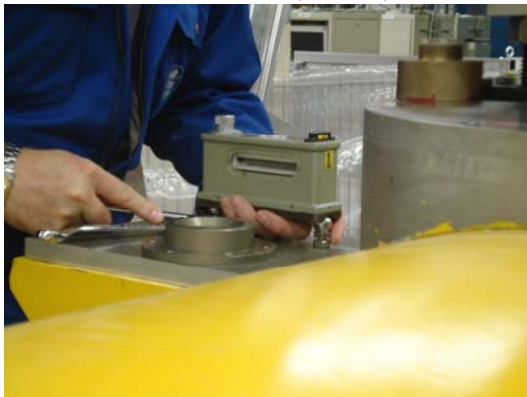
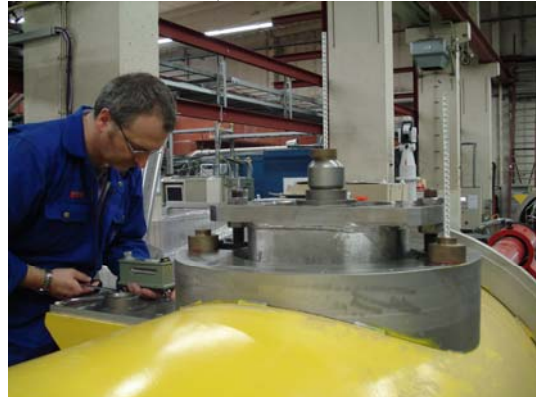
3. Using hand-held level, level tooling ball pair until parallel with cold mass mounting flange at each of the three post positions. Balls leveled by adjusting nuts on stem. (These tooling balls will be referenced for setting cryomodule rotation about beam (Z-axis) when installed in the tunnel.)

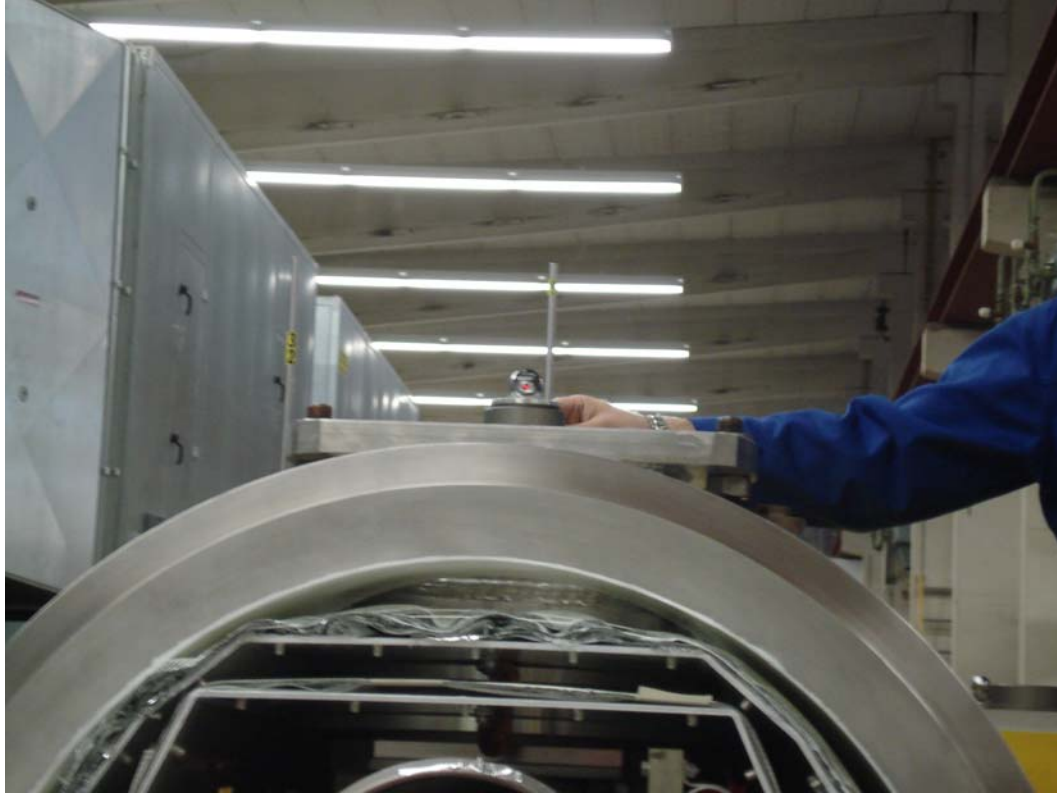
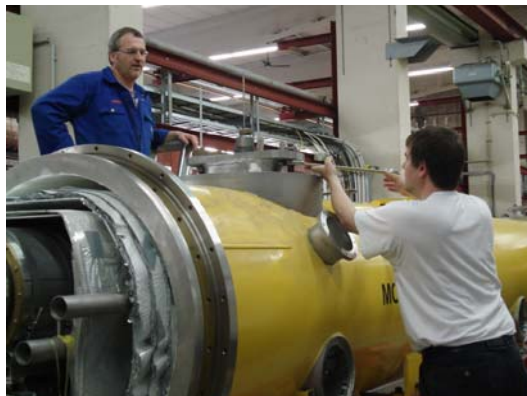
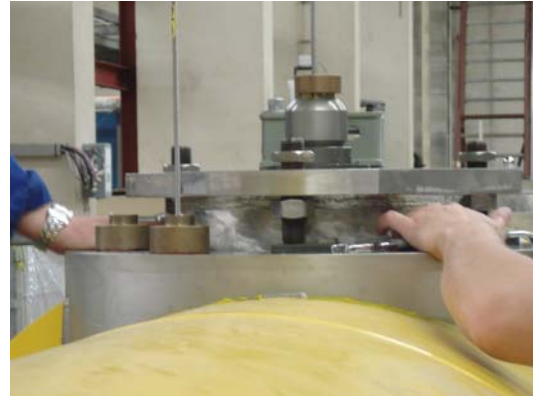
4. Align cold mass vertically (Y-direction) to vessel. Datum is top alignment flanges. Goal is to align cavity centerline, when cold, to match elevation of coupler flanges on vacuum vessel. Simultaneously maintain overall straightness of cavity string by matching dimensions from cavity center to mounting posts established during alignment on overhead fixture (see Week III, Day 8 – May 28, 2006).

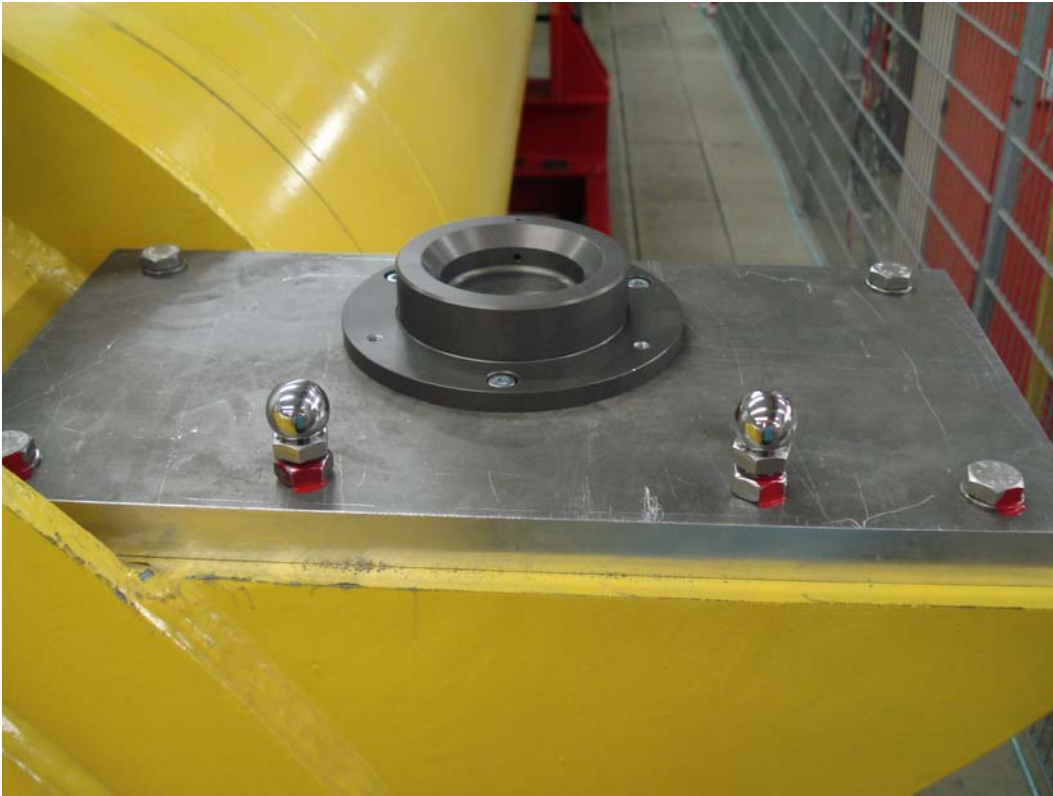
5. Align cold mass horizontally (X-direction) to vessel, again simultaneously maintaining cavity straightness using survey data collected while on overhead fixture.

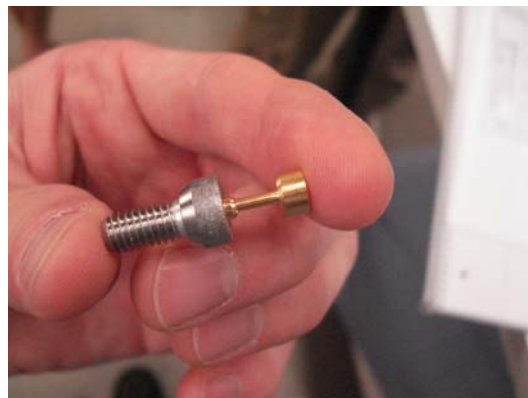
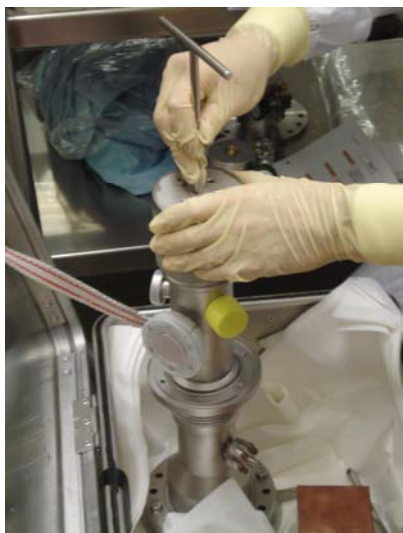
Electrical contact plunger removed from antenna. This is a spring-loaded plunger that makes contact with the BNC connector on the cold window protective cap. It is used for RF test of coupler/cavity. (W-D Moeller says it is a commercial item used in industry to test PC boards.)

Wiped knife edge on 80K flange on cold end assembly. CF gasket installed into 80K flange on cold end assembly. This gasket has edges on inside diameter rounded to eliminate sharps in RF volume. Gasket deformed out of round by striking it on edge on a hard surface so it snaps into the flange and holds itself in position.

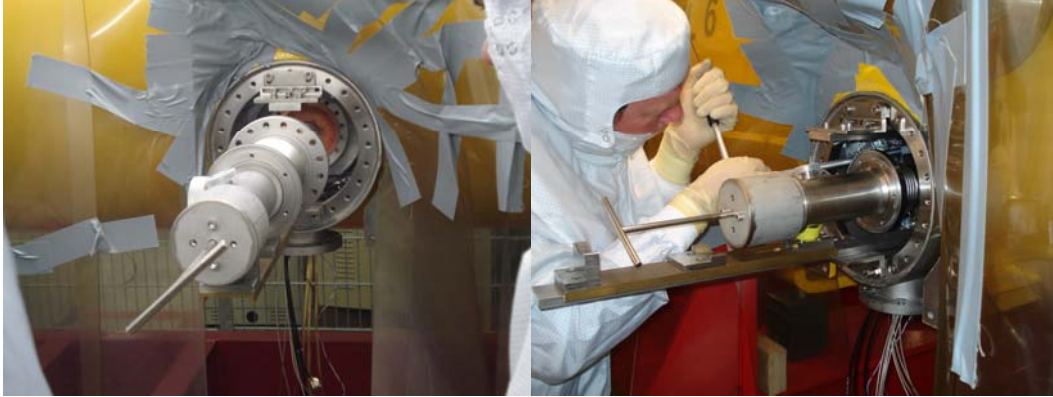
Warm end coupler assembly removed from protective box (stored under nitrogen). Long hex driver is inserted through back of the doorknob down the center of the inner antenna and engaged with the captive screw at the end of the antenna. This screw joins the cold end and warm end antennas. As stored, screw holds warm end assembly to a protective blank flange attached at 80K end. Screw loosened, disconnecting warm end assembly from flange blank. Wiped knife edge on 80K flange on warm end assembly.

Warm end coupler staged onto installation tooling and slid into position. Captive screw tightened, joining inner conductors of cold end and warm end assemblies. Couplers joined at the 80K flange with silicon bronze fasteners and tightened (without a torque wrench). Captive screw joining warm end and cold antennas was again tightened.

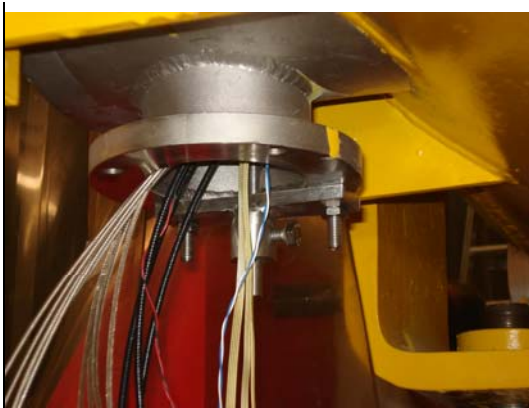
Temporary coupler support installed through instrumentation port below coupler. Installation tooling removed. Coupler hangs, held only by temporary support from below. It's bouncy when cantilevered like this. E-pickup cable attached and routed down through instrumentation port.

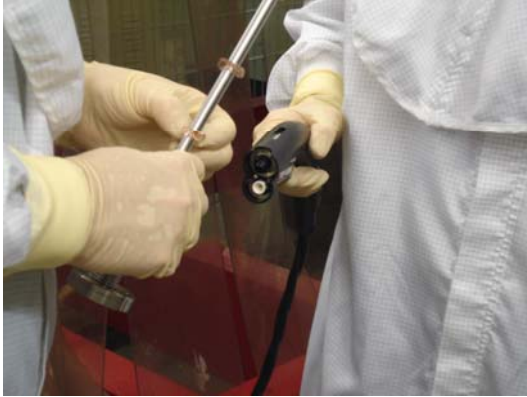
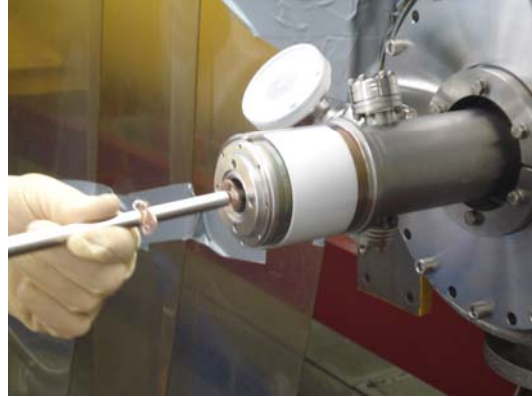
Protective cap removed from warm window. Tuning rod installed through back of doorknob. The rod end keys into a slot in the antenna and is captured with a 90° rotation. Springs wrapped around tuning rod are there for cancellation of possible reflection.

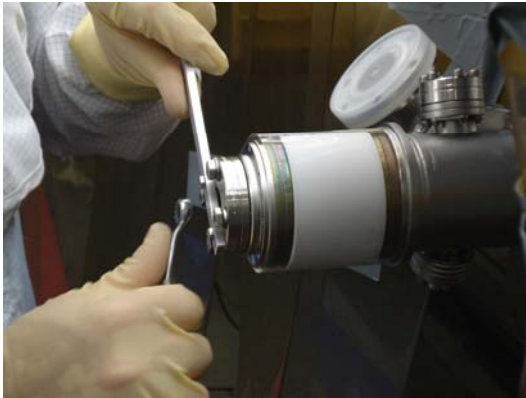
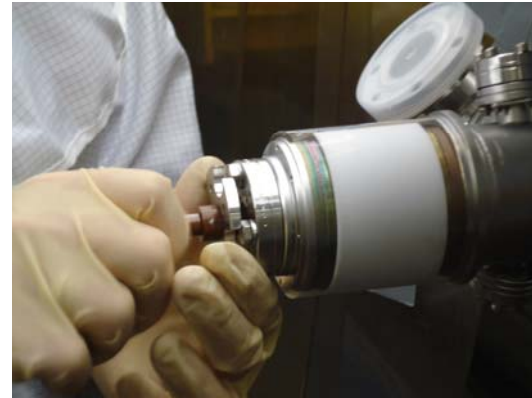
A handle is temporarily used on back of doorknob to react the torque applied when tightening fasteners so strain isn't imparted through ceramic warm window. Tuning rod secured to back of doorknob with CF seal. Tuning rod extension and flange installed on tuning rod. Protective cap installed over warm window.

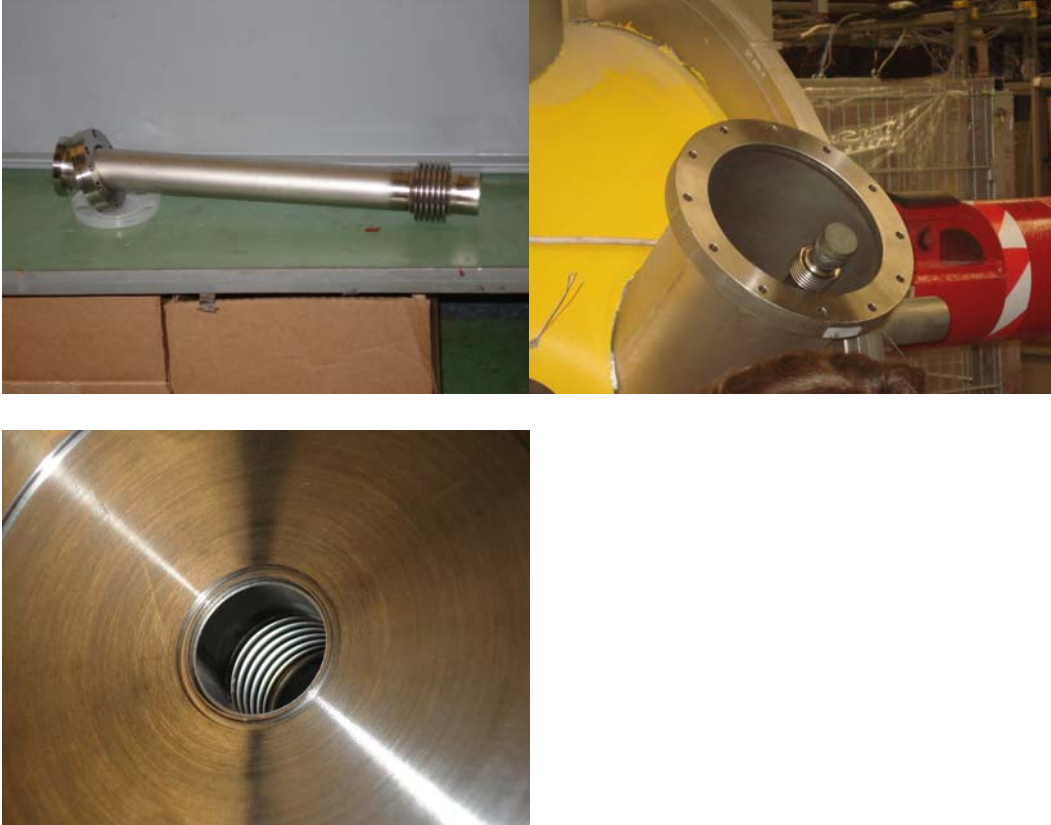
At quadrupole superconducting lead feed-through, connection tube installed with rotatable 2.75" CF flange at one end and bellows at the other. This is the tube that the superconducting leads feed through from outside the vessel to the magnet. Leaked checked this CF joint by first plugging all holes at end of cryomodule with machined plugs and sealant similar to Apiezon Q-wax. Superconducting leads installed through flange.

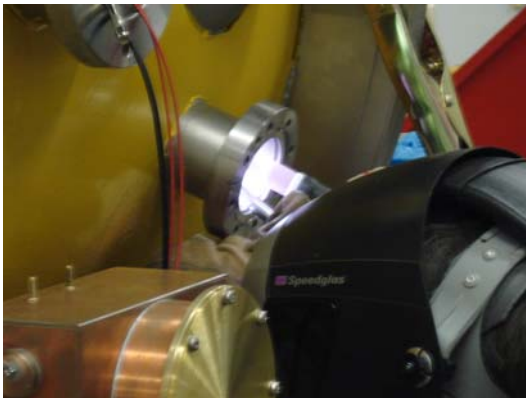
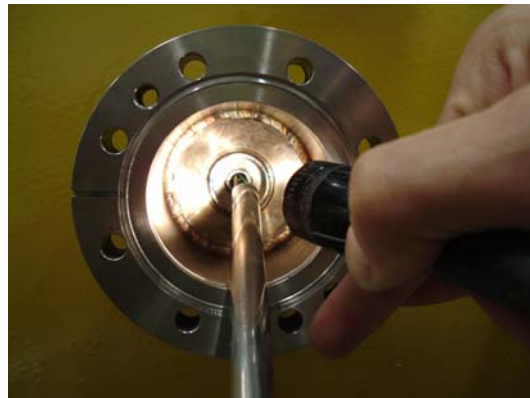
TIG welded superconducting leads feed-through stub to vessel flange. Also welded small ~0.5" tube stub below it at "potential" flange (low power supply to magnet). Leak checked these welds.

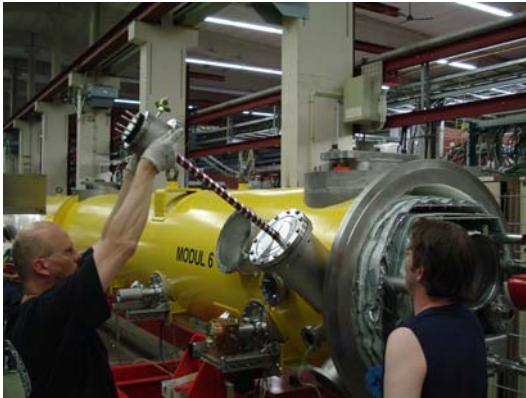
Superconducting leads inserted and sealed to vessel flange with indium seal. (Sometimes the heater fails so this flange can become very cold. Indium is the best material to maintain the seal.) The indium seal was leak checked.

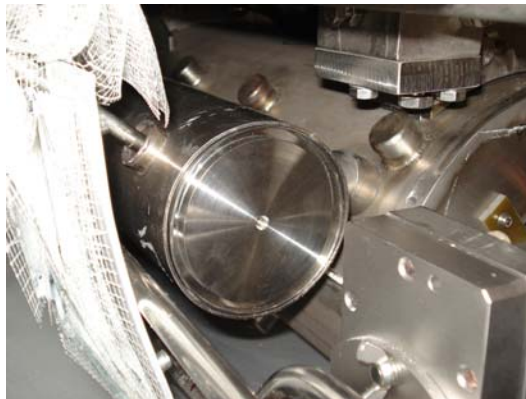
Leads tested for continuity and proper labeling. Leads soldered together inside G10 board with copper lined grooves. Copper is a foil. Leads sealed into “wiring box” with plug prepared with welding groove. This weld and final leak check will be completed Monday, June 19.
